# Inspection report

| Inspection Order No. | PO 000340 |
| Product Description | Gate Valves |
| Inspection Date | Oct. 8th to 9th 2016 |

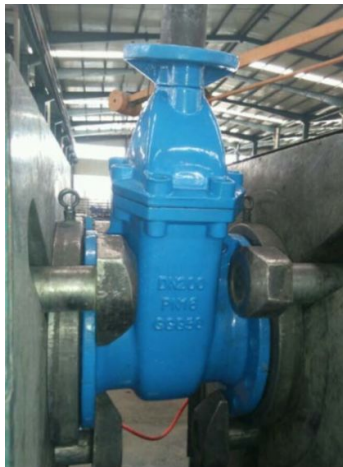
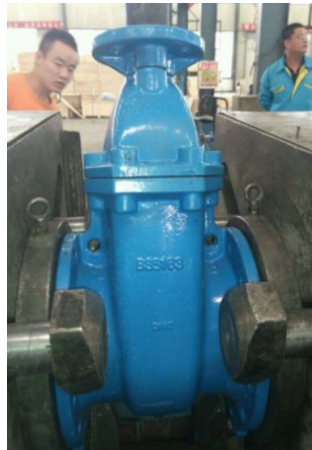
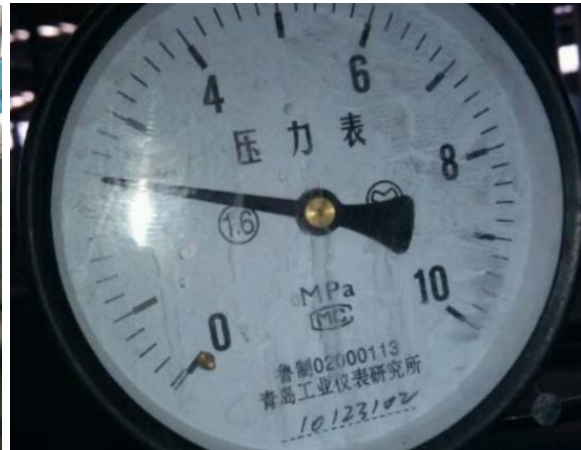
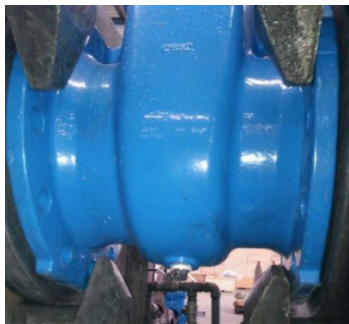
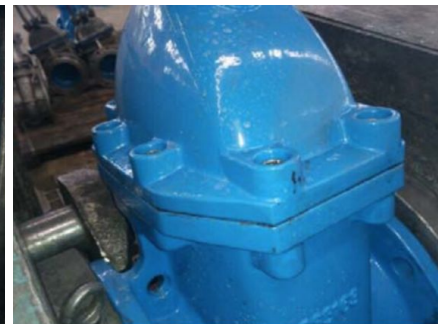
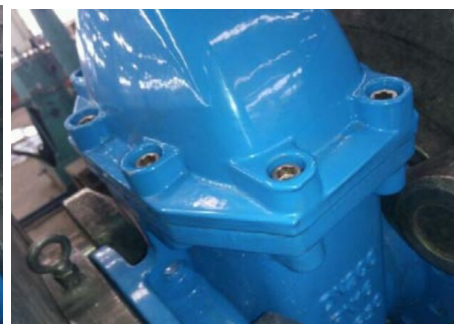
### SHELL TEST IMAGES

### DN200 Gate Valve with Gear Box - **PASS**

Zero leaking on both shell test and seal test.

Shell test pressure  $\geq 1.5$  times nominal pressure (24 bars for PN16)

Seal test pressure  $\geq 1.1$  times nominal pressure (17.6 bars for PN16)

Shell test pressure  $\geq 180$ s.

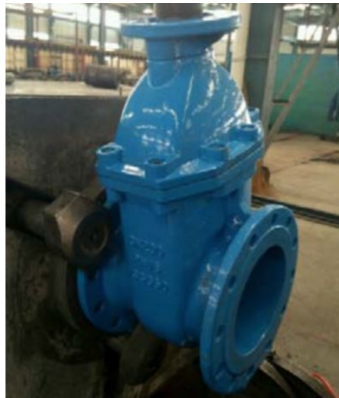
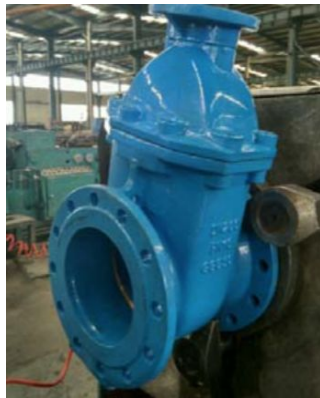
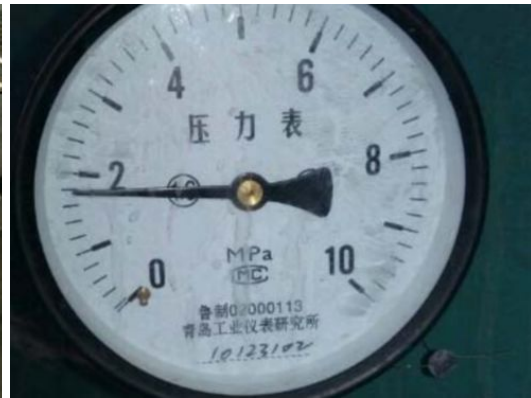
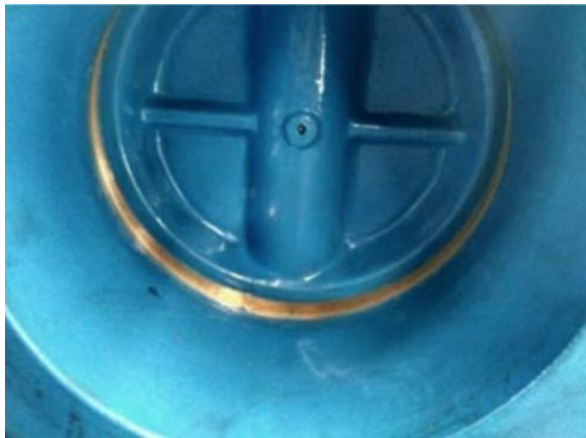
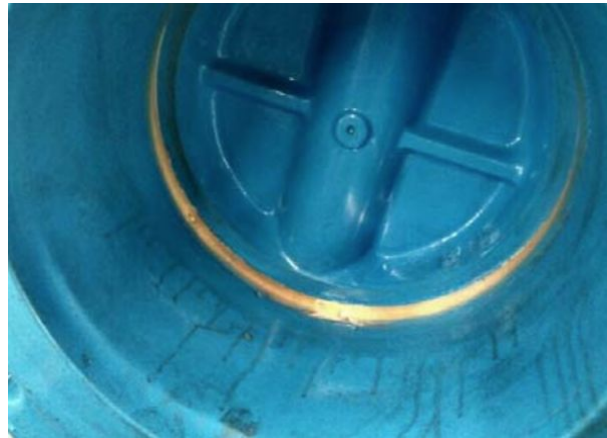
**SEAL TEST IMAGES**

Seal test pressure for  $\geq 60$ s.

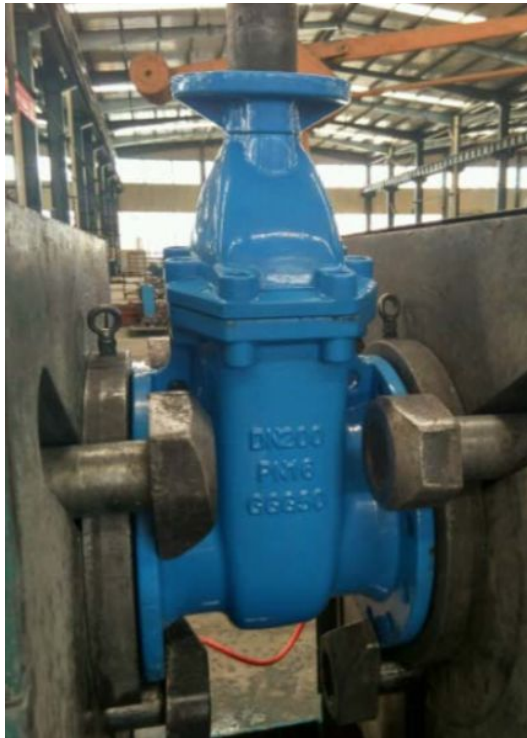
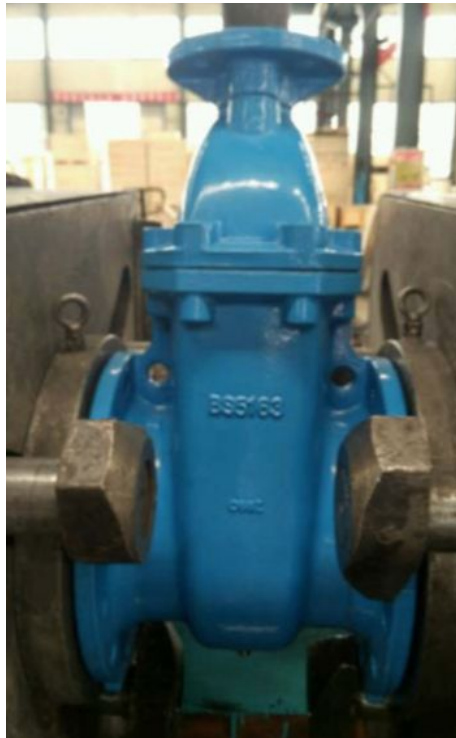
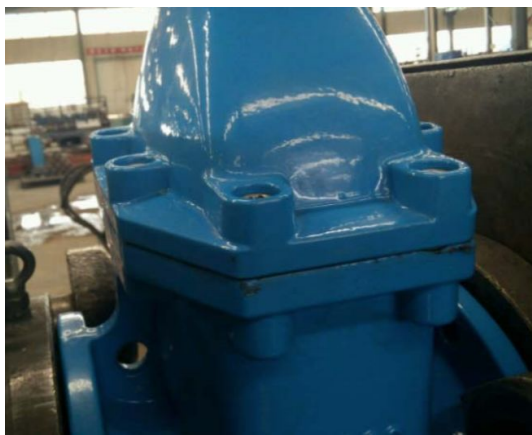
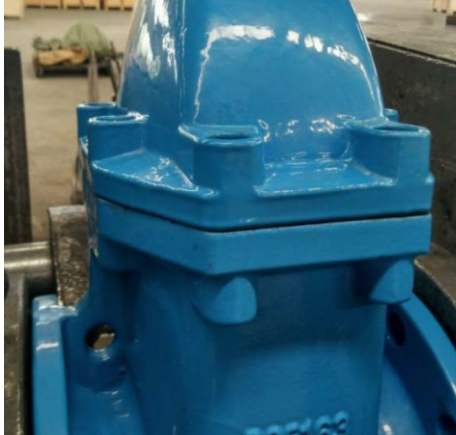
**SHELL TEST IMAGES**

**DN200 Gate Valve - PASS**

Zero leaking on both shell test and seal test

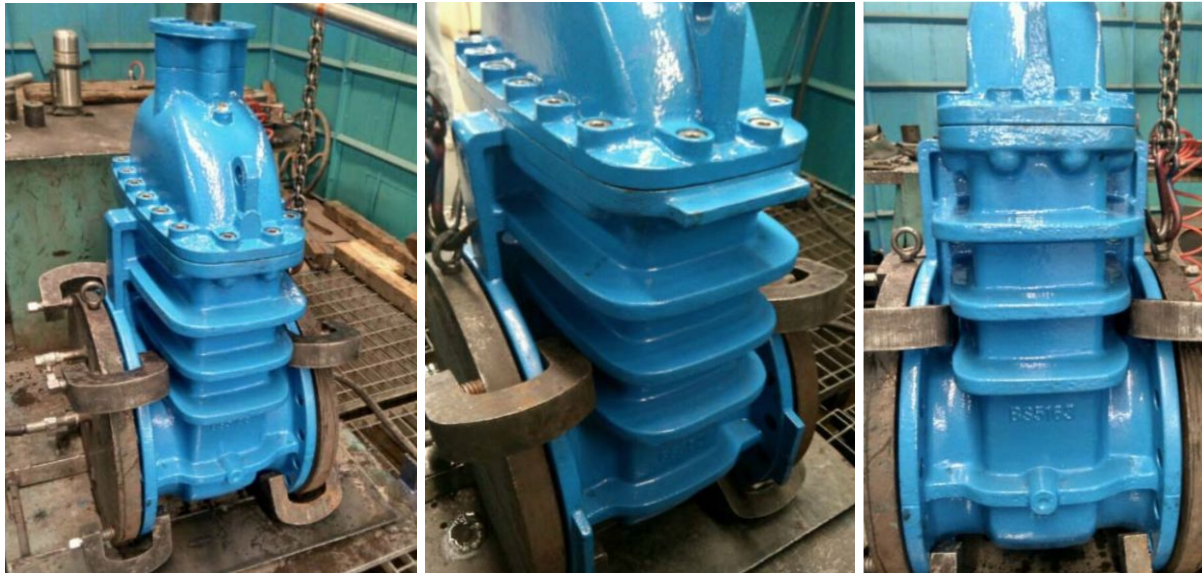
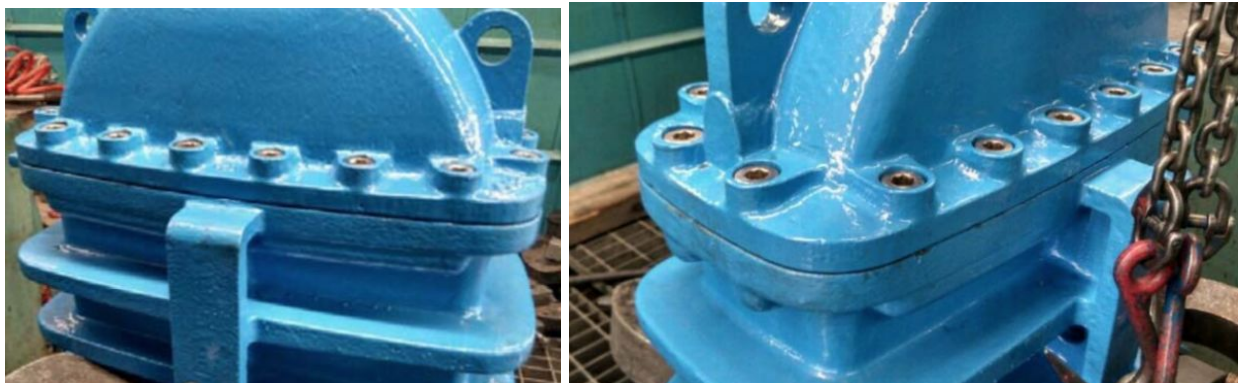
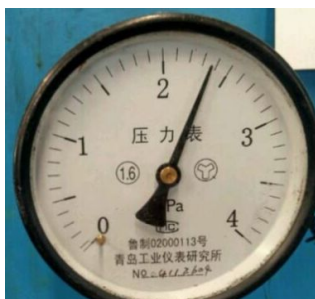
**SHELL TEST IMAGES**

**DN450 Gate Valve - PASS**

Zero leaking on both shell test and seal test

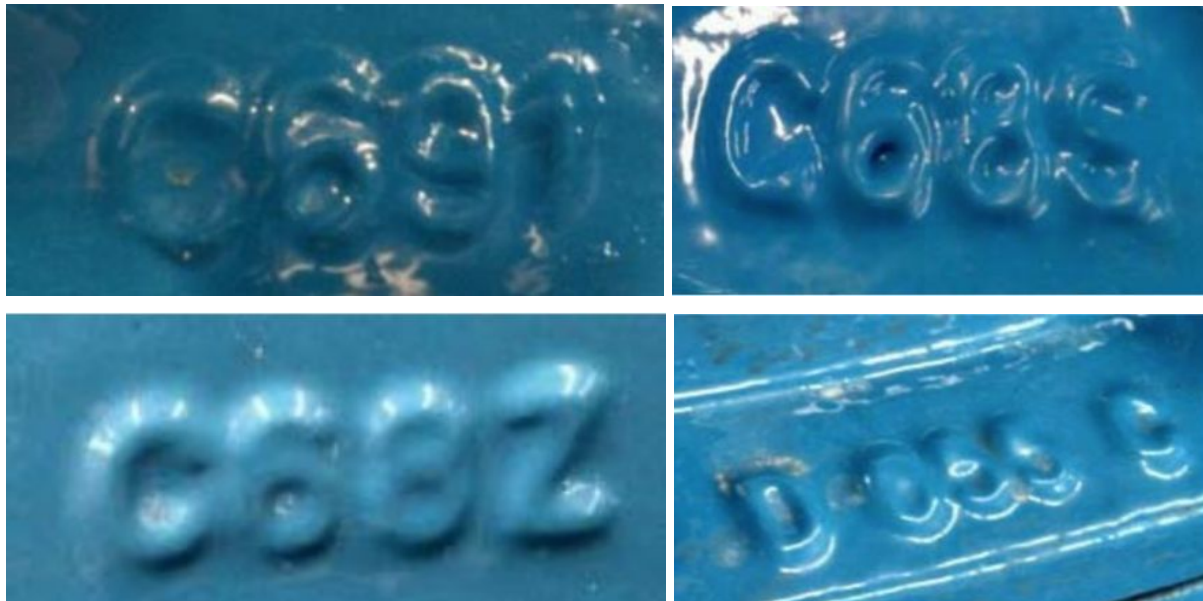
Heat codes

Checked the material date according to the material certificates of chemical component and mechanical property provided by factory.

NB. For example of DN450 Gate Valve, **C691** on 1st Sep. 2016.

- **C** means made by electric furnace
- **6** means 2016
- **9** means Sep.
- **1** means 1st

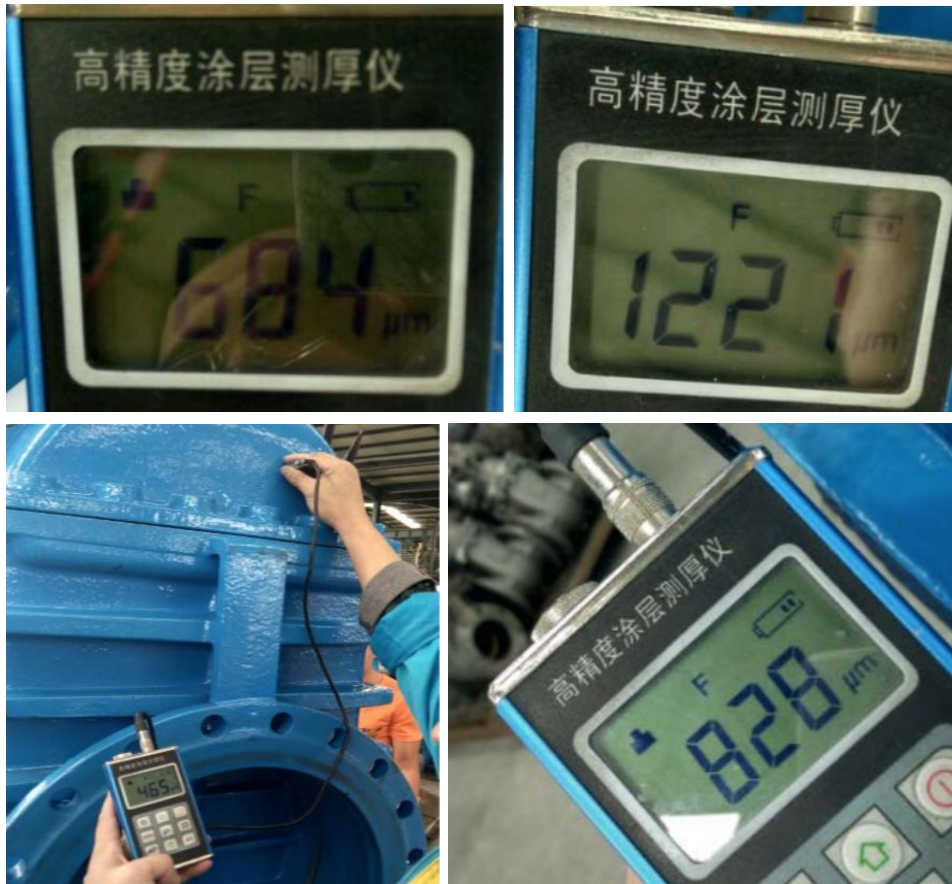
### PAINT TEST IMAGES

The painting thickness is from 684 to 1221 $\mu$ m on DN200 gate valves and 465 to 828 $\mu$ m.

Checked all valves on painting and appearance. All valves have not yet been cleaned and repaired when I inspected, so there are some painting and appearance issues on the flange and body surface. I had asked the factory have to repaint or repair all defective valves before shipping.

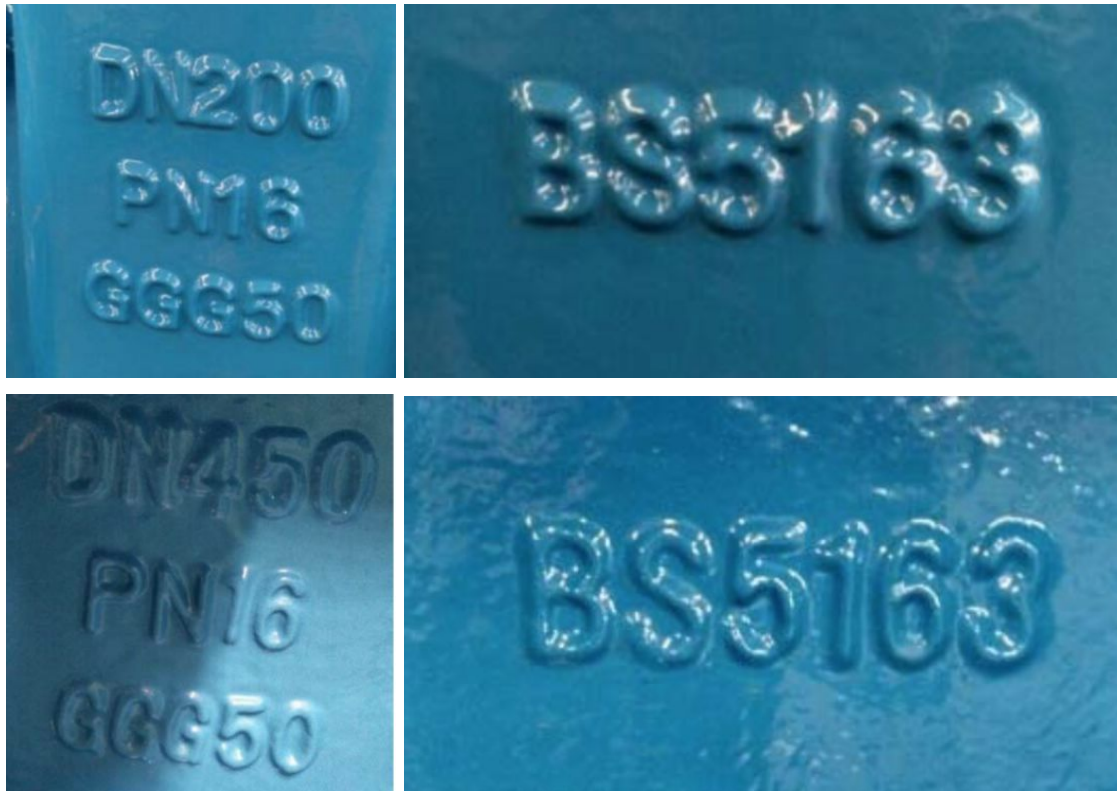
## 6. Nameplate & Marking

Markings are ok.
